**PHASE 2 GROUND INVESTIGATION:
CONWY ACTIVE TRAVEL RSPB**

GSL2996/R01

Conwy County Borough Council

GroundSolve Ltd

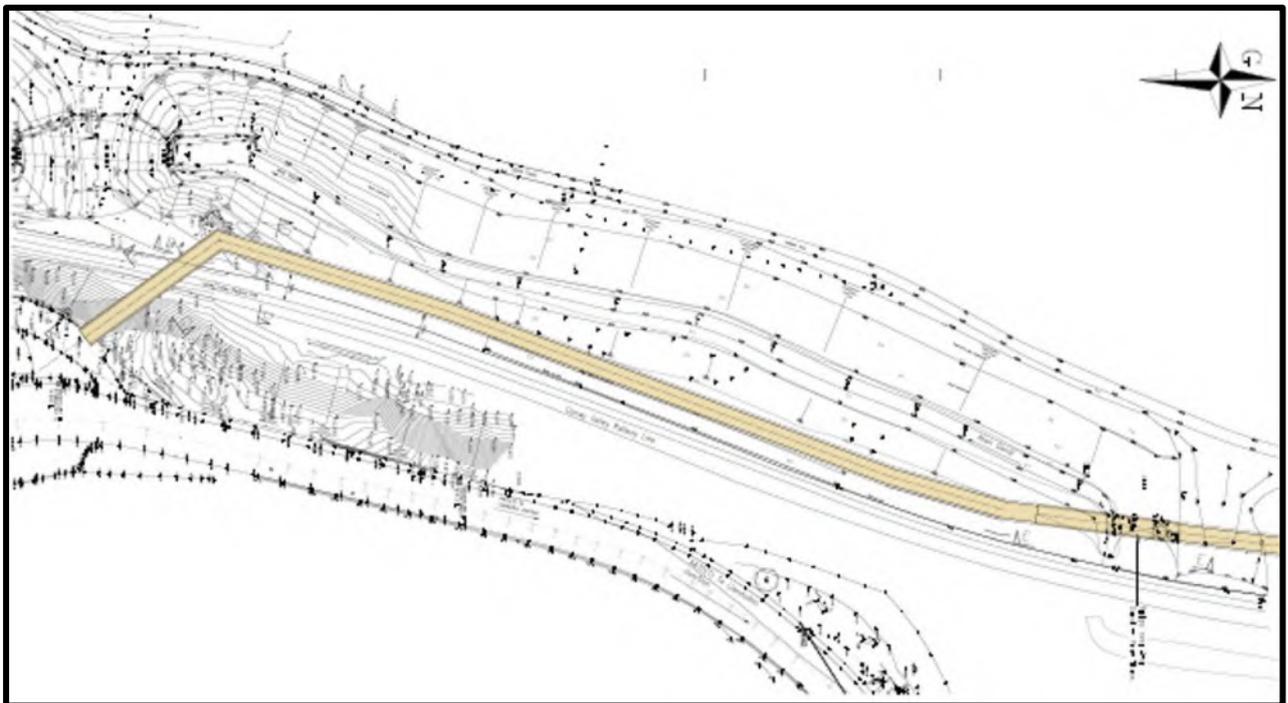
Extract from proposed development plan.

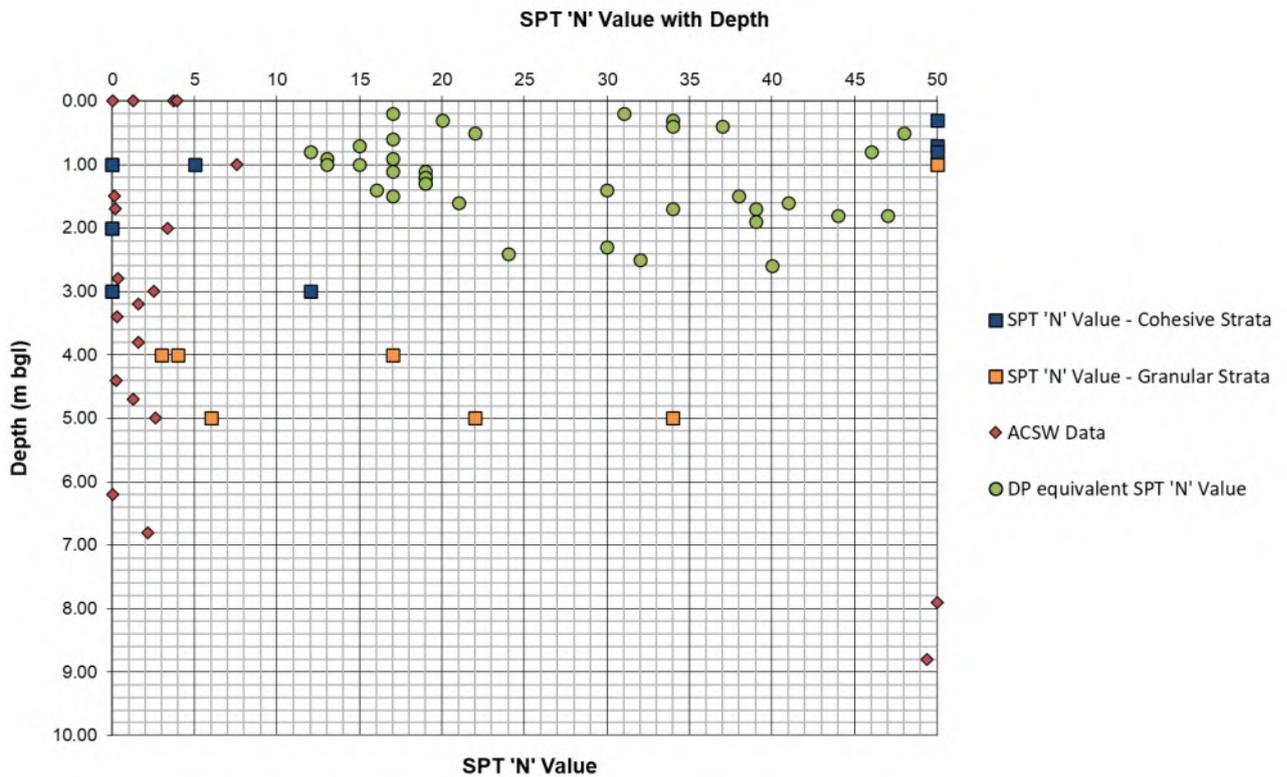
Table 9.3: Summary of SPT 'N' Values

The SPT 'N' values vary within the silt/clay from 0 to 12 with an average of 10, and in the gravel with a value of 50. There is no general trend to the SPT N values.

Generally where the natural silt is encountered the 'N' values are low which matches the consistencies encountered and the ACSW data. At a depth of around 4.00m to 5.00m below ground level slightly stronger sand is encountered,

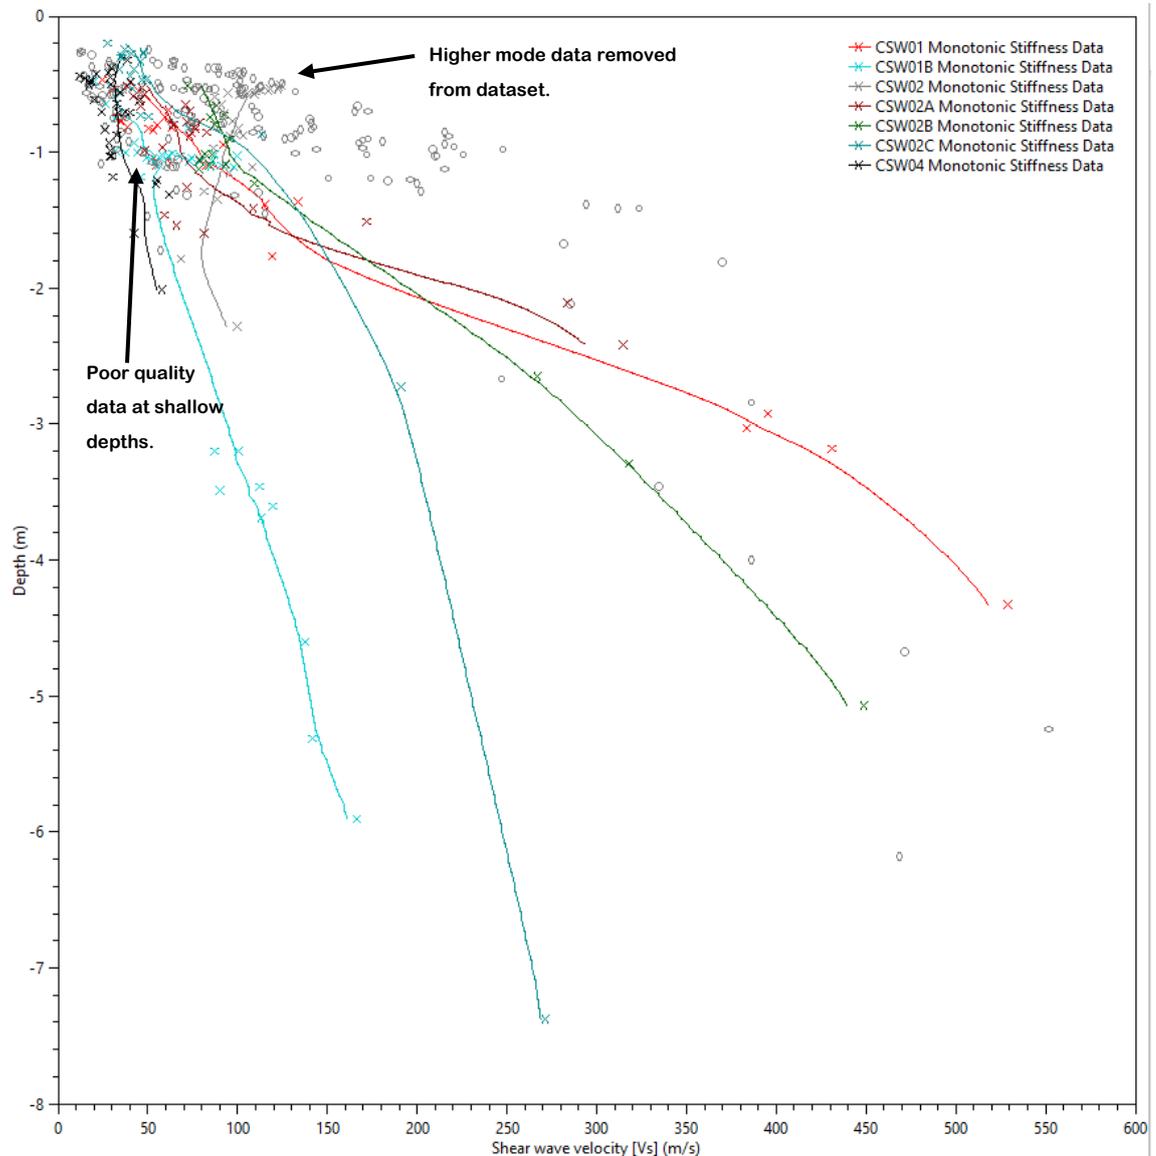
Figure 5-1: Superimposed graph showing simple inversions of ACSW tests CSW01, 01B, 02, 02A, 02B, 02C & 04.

Figure 5-1 indicates a large proportion of ACSW tests contain poor quality data at shallow depths. This poor quality data has been ignored (as shown by the grey circles in Figure 5-1). Due to the poor quality of the data recorded, the ACSW equipment was replaced on site with spare equipment in order to rule out any equipment errors or failure. It was deemed that there were no issues with the testing equipment and that the poor quality data recorded was due to difficult ground conditions.

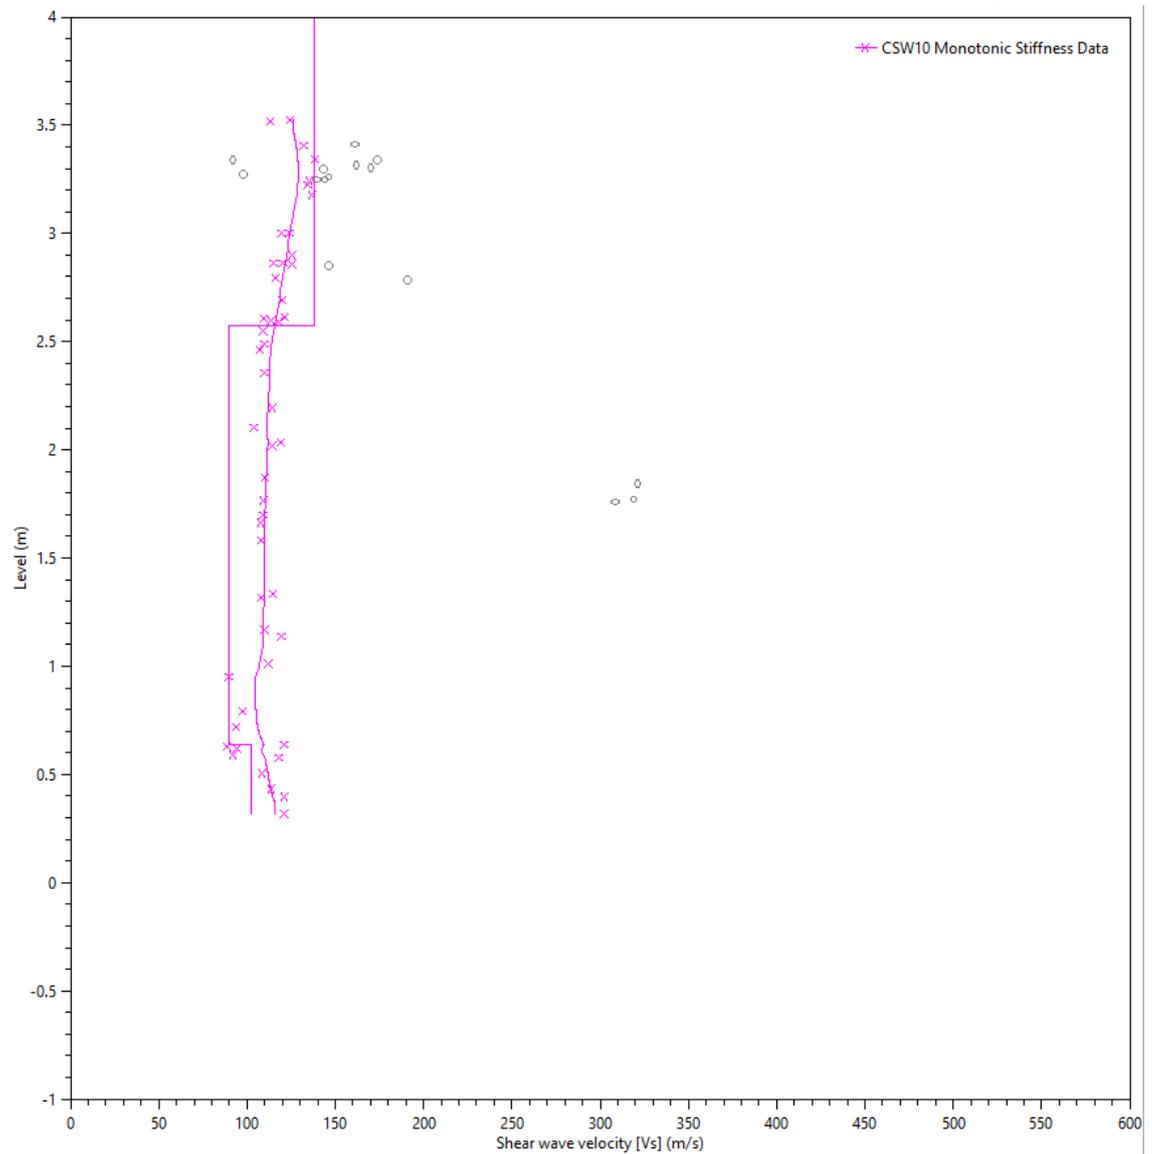
Figure 5-2: Simple and Advanced Inversions of CSW10.

There is a gradual reduction in stiffness with depth, shown in Figure 5-2, to ~3.5m bgl (0.5mAOD). This is shown by the decrease in values of strain softened stiffness and shear wave velocity. This geological layer equates to a shear wave velocity of 90m/s, a strain softened stiffness of 13MPa and an undrained shear strength of 18kPa. The closest window sample log suggests the likely presence of a cohesive tidal flat material.

There is a slight increase in stiffness with depth at ~4.0m bgl, showing an increase in shear wave velocity to 103m/s, which equates to a strain softened stiffness of 16MPa and an undrained shear strength of 24kPa.

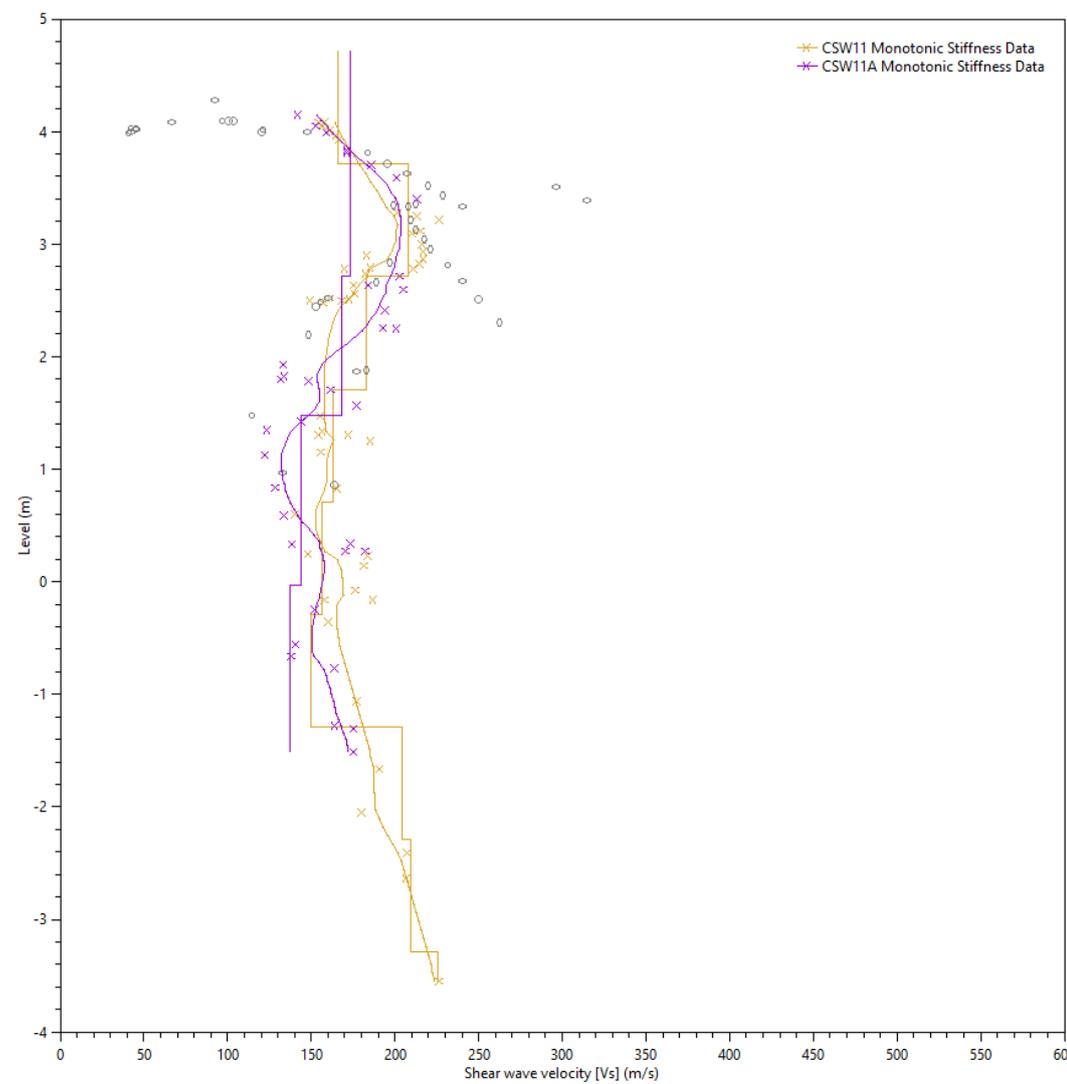
Figure 5-3: Simple and Advanced inversions for CSW11 and CSW11A.

The proposed footbridge is anticipated to cross the Afon Ganol, starting roughly at the location of CSW10 and ending roughly at the location of CSW11.

It is anticipated that the stiffer Made Ground stops at ~1.7m AOD and soils at ~2.7m AOD are less stiff than the anthropogenic soils and could possibly represent the tidal flat deposits at depth.

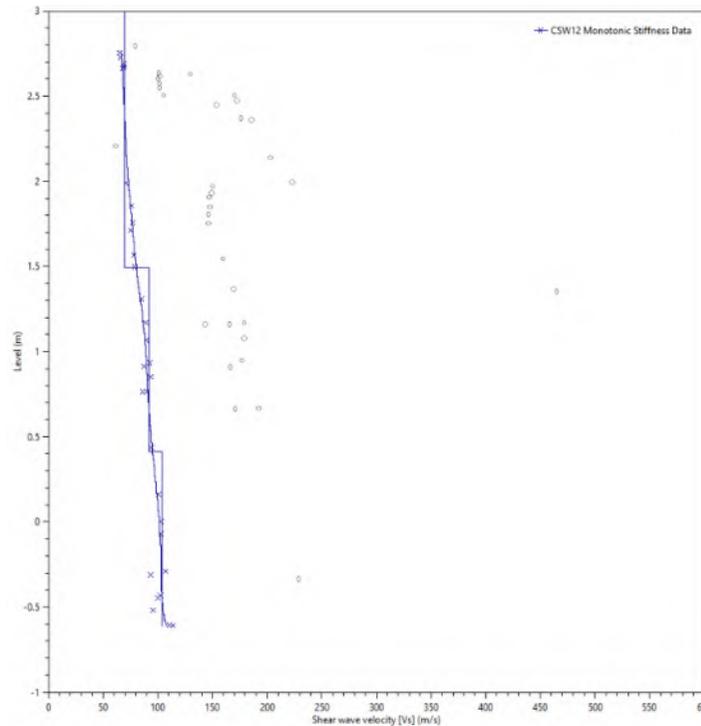
Figure 5-4: Simple and Advanced inversions for CSW12.

A screenshot of the WS105 log is provided in Figure 5-5, and has been placed adjacent to the CDAS superimposed simple and advanced inversions graph of CSW12 in order to provide a comparison between the WS log data and the ACSW data. Both results show soft material, that increase in stiffness at ~4.0m depth. CSW12 was taken at 3.20mAOD compared to WS105 which was taken at 2.88mAOD, therefore the results are recorded at slightly different levels but the results are similar with depth.

Sample and In Situ Testing			Depth (m)	Level (m)	Legend	Stratum Description
Depth (m)	Type	Results				
0.00	B				XXXXXX	Firm brown slightly sandy clayey SILT. Sand fine to medium.
0.00	ES					
0.50	PP	58.9 kPa				
1.00	B		1.00	1.88	XXXXXX	Soft very low strength dark brown sandy clayey SILT. Sand fine to medium.
1.00	ES					
1.00	SPTL					
	S					
1.00	SPT	N=0 (0,0/0,0,0,0)				
1.50	PP	2.4 kPa				
2.00	B		2.00		XXXXXX	
2.00	SPTL					
	S					
2.00	SPT	N=0 (1,0/0,0,0,0)				
3.00	B		3.00		XXXXXX	
3.00	SPTL					
	S					
3.00	SPT	N=0 (1,0/0,0,0,0)				
4.00	B		4.00	-1.12	XXXXXX	Loose brownish grey silty SAND. Sand fine to coarse.
4.00	ES					
4.00	SPTL					
	S					
4.00	SPT	N=4 (0,0/0,0,2,2)				
5.00	SPTL		5.45	-2.57	XXXXXX	
	S					
5.00	SPT	N=6 (3,2/2,2,1,1)				
End of Borehole at 5.450m

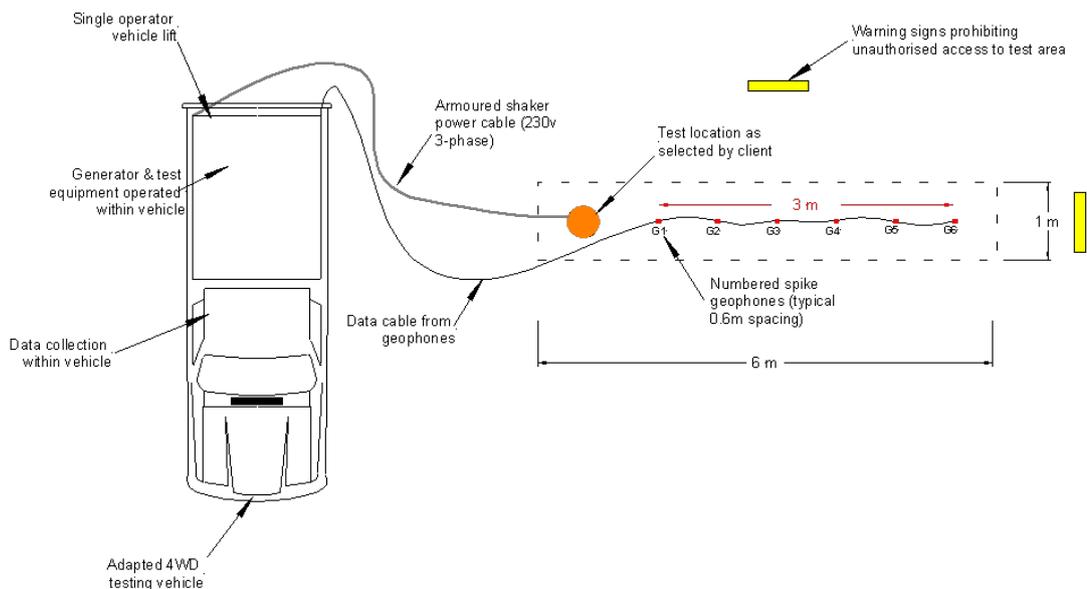
Figure 1 – Standard ACSW test layout

Advanced Continuous Surface Wave (ACSW) testing is a proprietary engineering testing system developed by ground Stiffness Surveys Limited (GSS) based on the general methodology for Continuous Surface Wave testing set out in Heymann, 2007. This system is being used under exclusive licence by SoilSafe Ltd. Surface Rayleigh wave velocities over a range of frequencies are accurately measured using a short array of geophones to produce a *dispersion curve* plot of Rayleigh wave velocity (V_r) against frequency. This data can then be used to generate a reliable shear wave velocity (V_s) with depth profile, which in turn can be converted to a stiffness profile using standard relationships. Typical ACSW profile depths are 10m to 15m using the GSS Standard Shaker but are dependent on the stiffness of the ground (deeper profile depths are obtained in stiffer ground for the same test frequency).
