**PHASE 2 GROUND INVESTIGATION:
CONWY ACTIVE TRAVEL RSPB**

GSL2996/R01

Conwy County Borough Council

GroundSolve Ltd

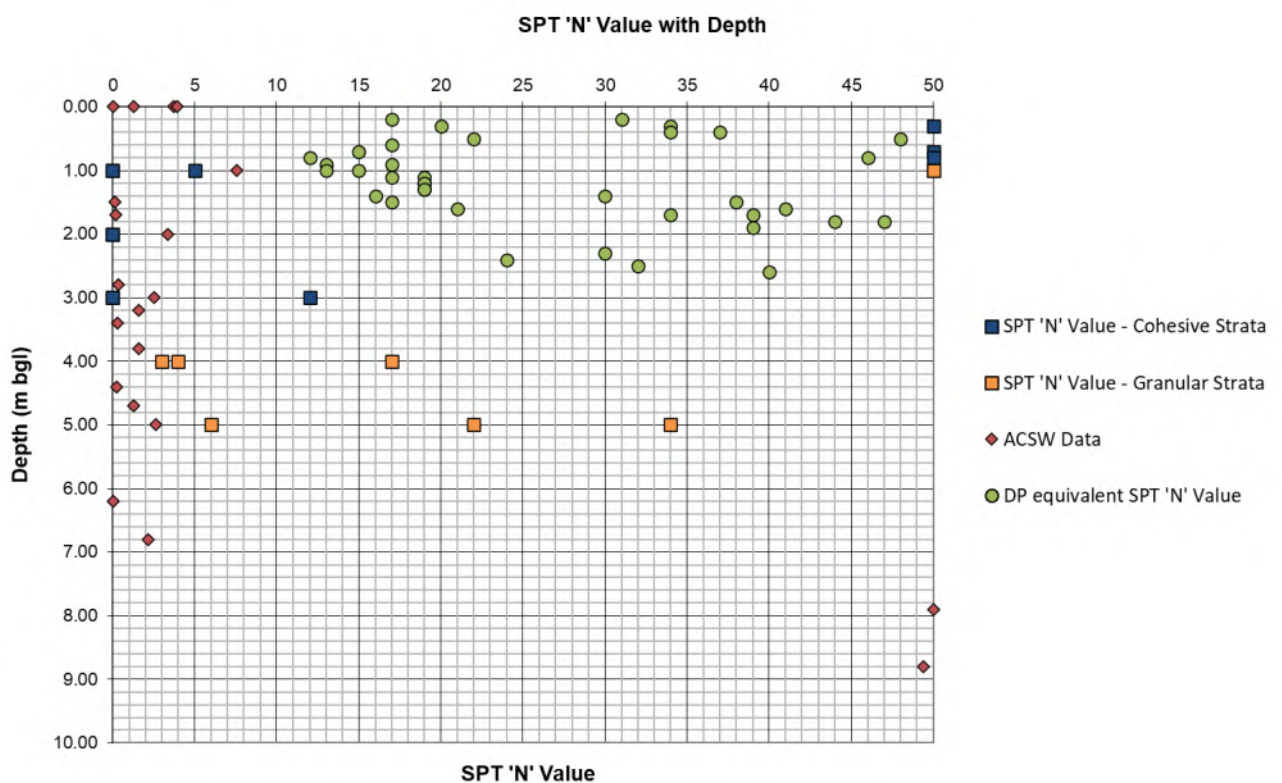
Table 9.3: Summary of SPT 'N' Values

The SPT 'N' values vary within the silt/clay from 0 to 12 with an average of 10, and in the gravel with a value of 50. There is no general trend to the SPT N values.

Generally where the natural silt is encountered the 'N' values are low which matches the consistencies encountered and the ACSW data. At a depth of around 4.00m to 5.00m below ground level slightly stronger sand is encountered,

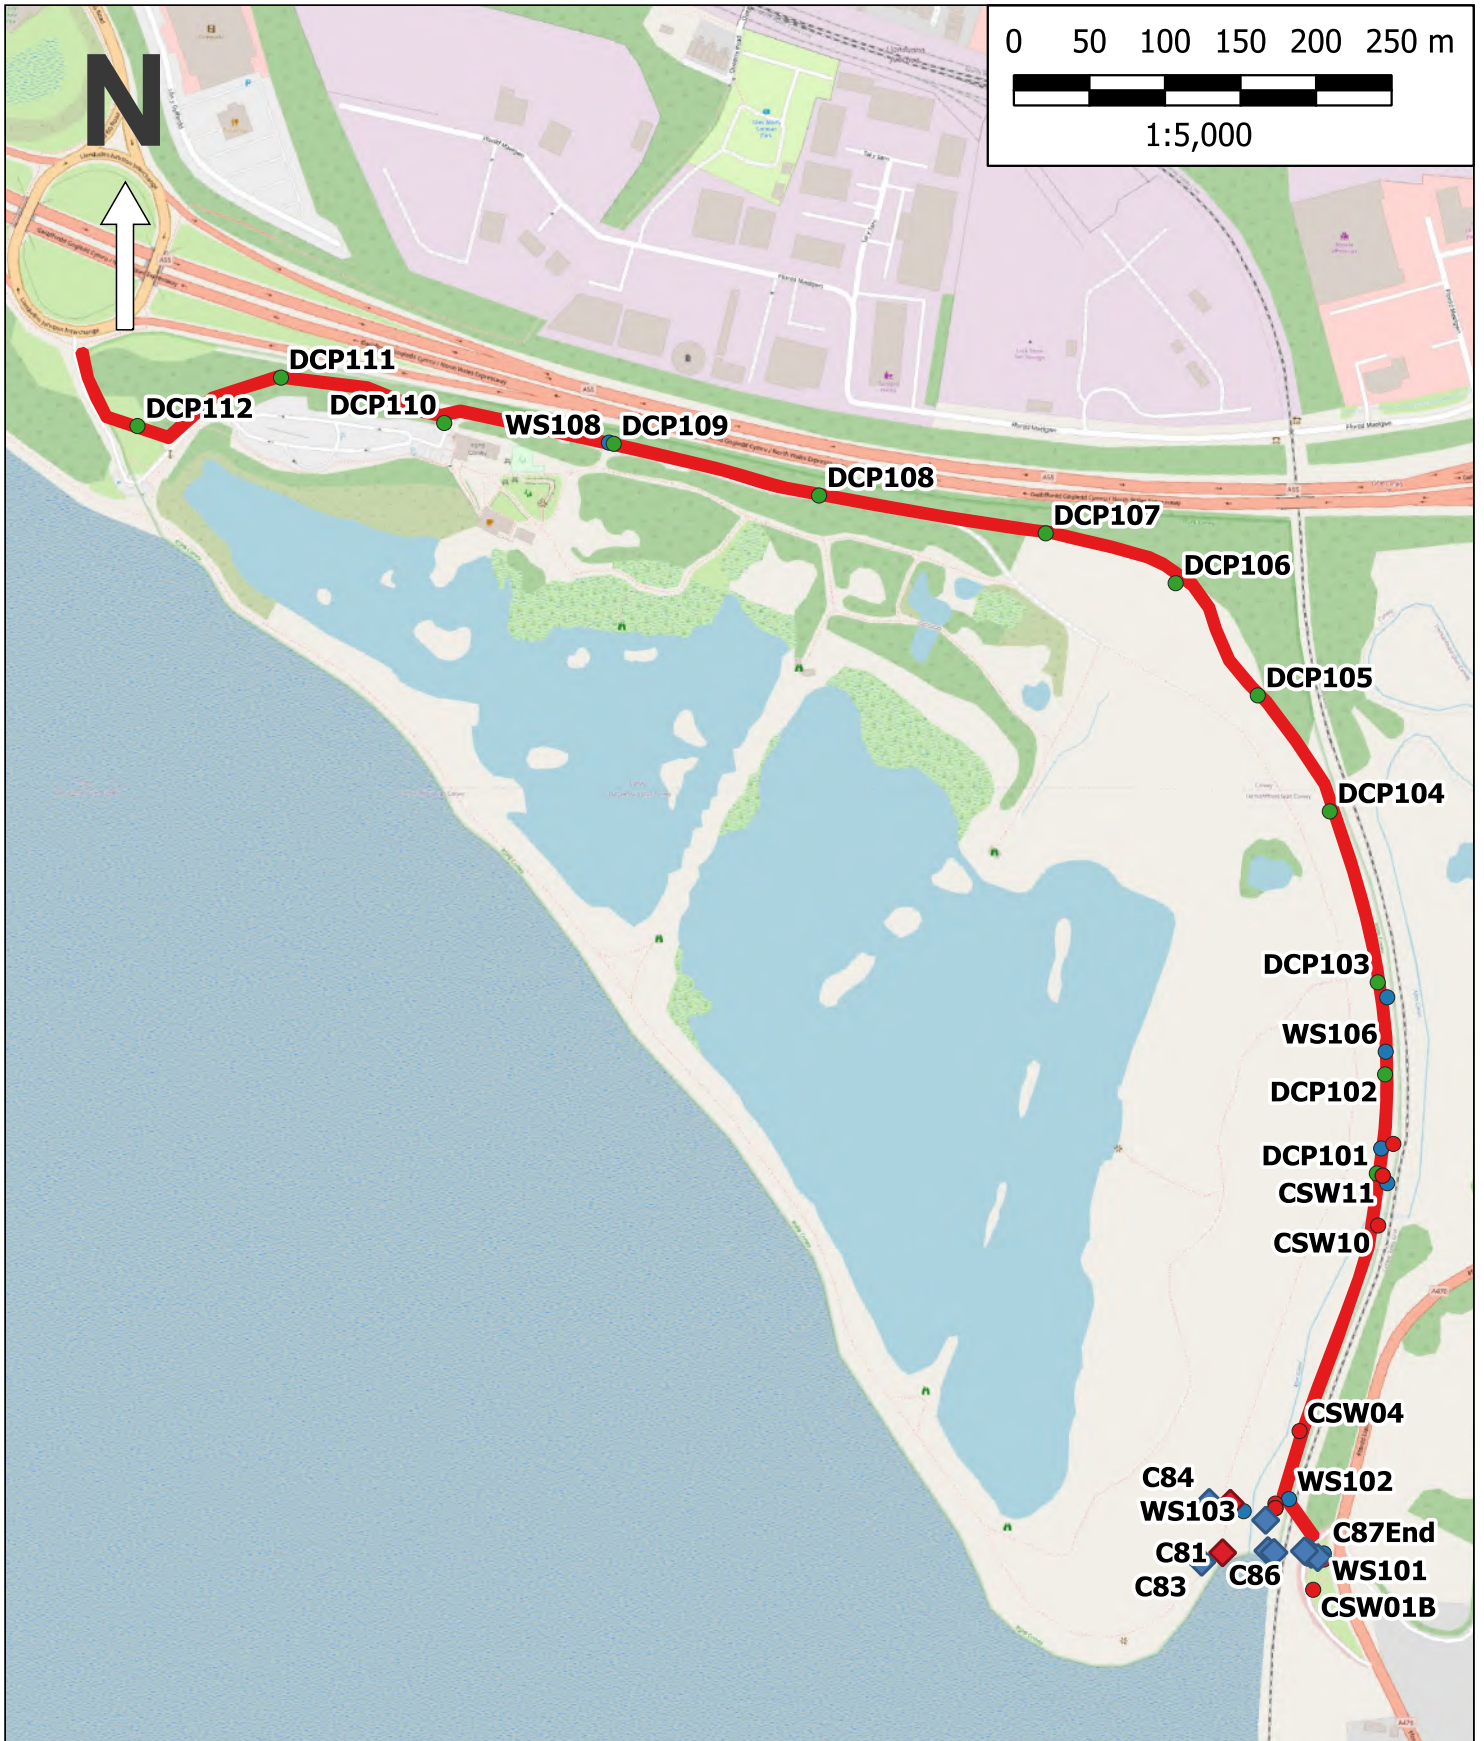
Figure: 2

Investigation locations are shown in **Figure 2** alongside the locations of the investigation works conducted by Geotechnics (2006). A more detailed view of the two potential bridge locations is given in **Figure 2A** (the culvert location) and **Figure 2B** (the 'piling mat' location).

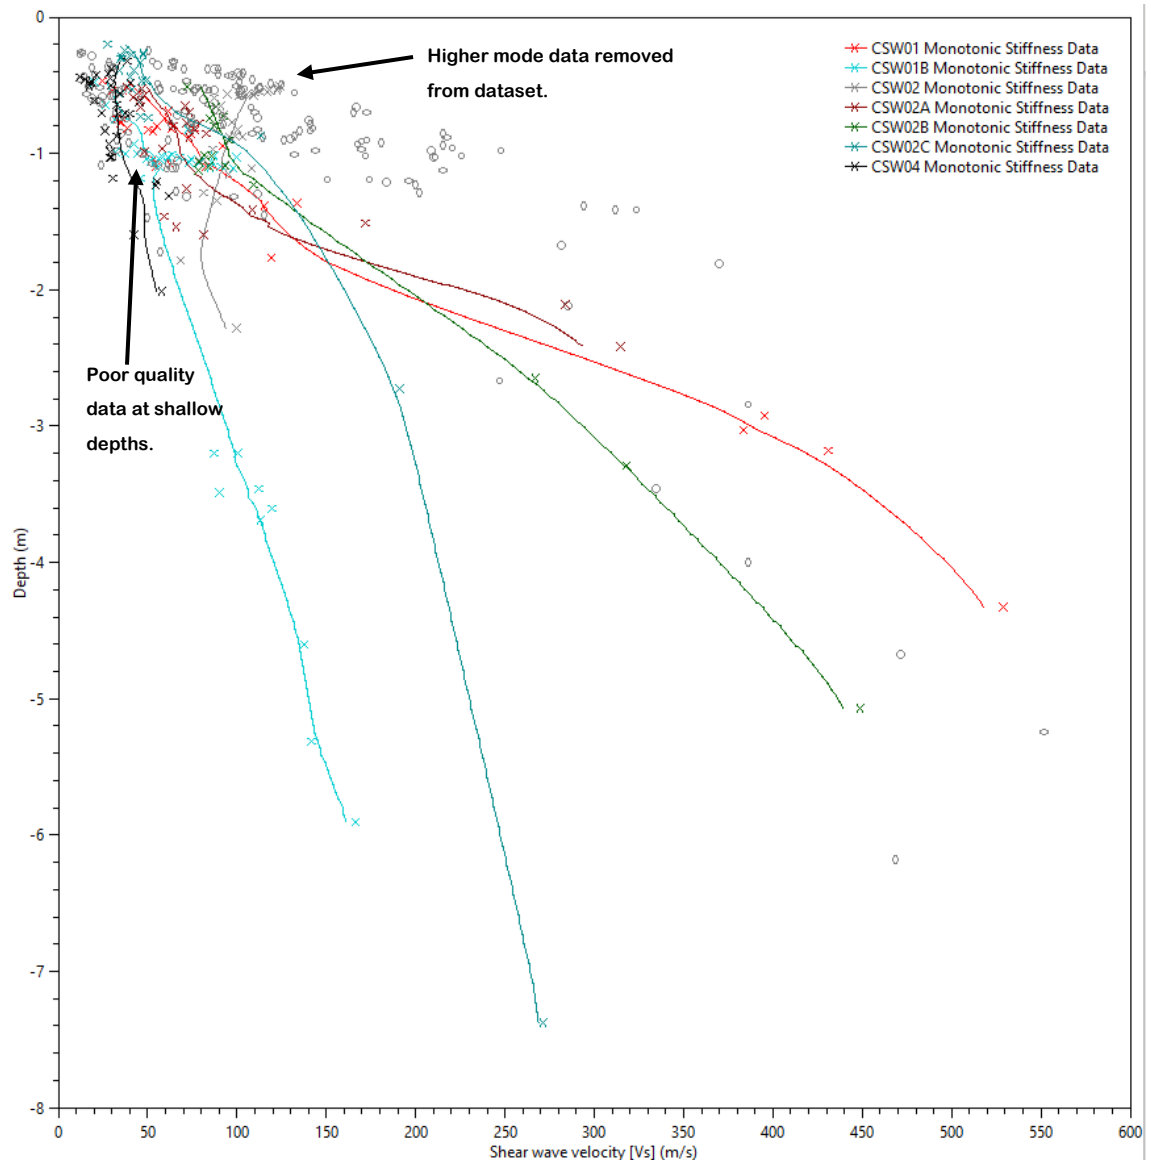
Figure 5-1: Superimposed graph showing simple inversions of ACSW tests CSW01, 01B, 02, 02A, 02B, 02C & 04.

Figure 5-1 indicates a large proportion of ACSW tests contain poor quality data at shallow depths. This poor quality data has been ignored (as shown by the grey circles in Figure 5-1). Due to the poor quality of the data recorded, the ACSW equipment was replaced on site with spare equipment in order to rule out any equipment errors or failure. It was deemed that there were no issues with the testing equipment and that the poor quality data recorded was due to difficult ground conditions.

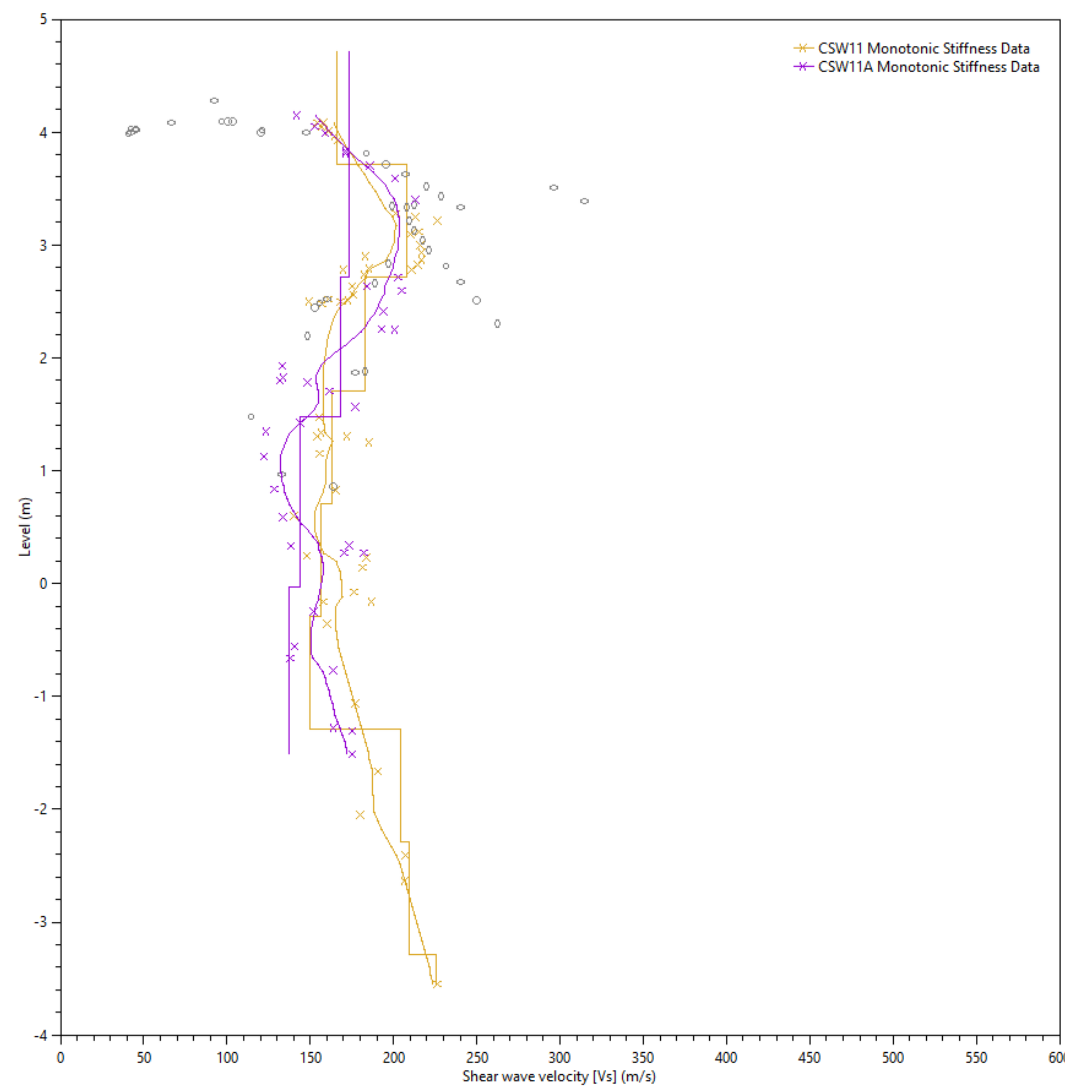
The proposed footbridge is anticipated to cross the Afon Ganol, starting roughly at the location of CSW10 and ending roughly at the location of CSW11.

It is anticipated that the stiffer Made Ground stops at ~1.7m AOD and soils at ~2.7m AOD are less stiff than the anthropogenic soils and could possibly represent the tidal flat deposits at depth.

Figure 5-3: Simple and Advanced inversions for CSW11 and CSW11A.
